# CELEBRATING COPPER CRAFTSMANSHIP

**Replacement of the failed galvanized tin roofs on this distinctive house with beautifully detailed copper has added a new dimension to its unique design.**

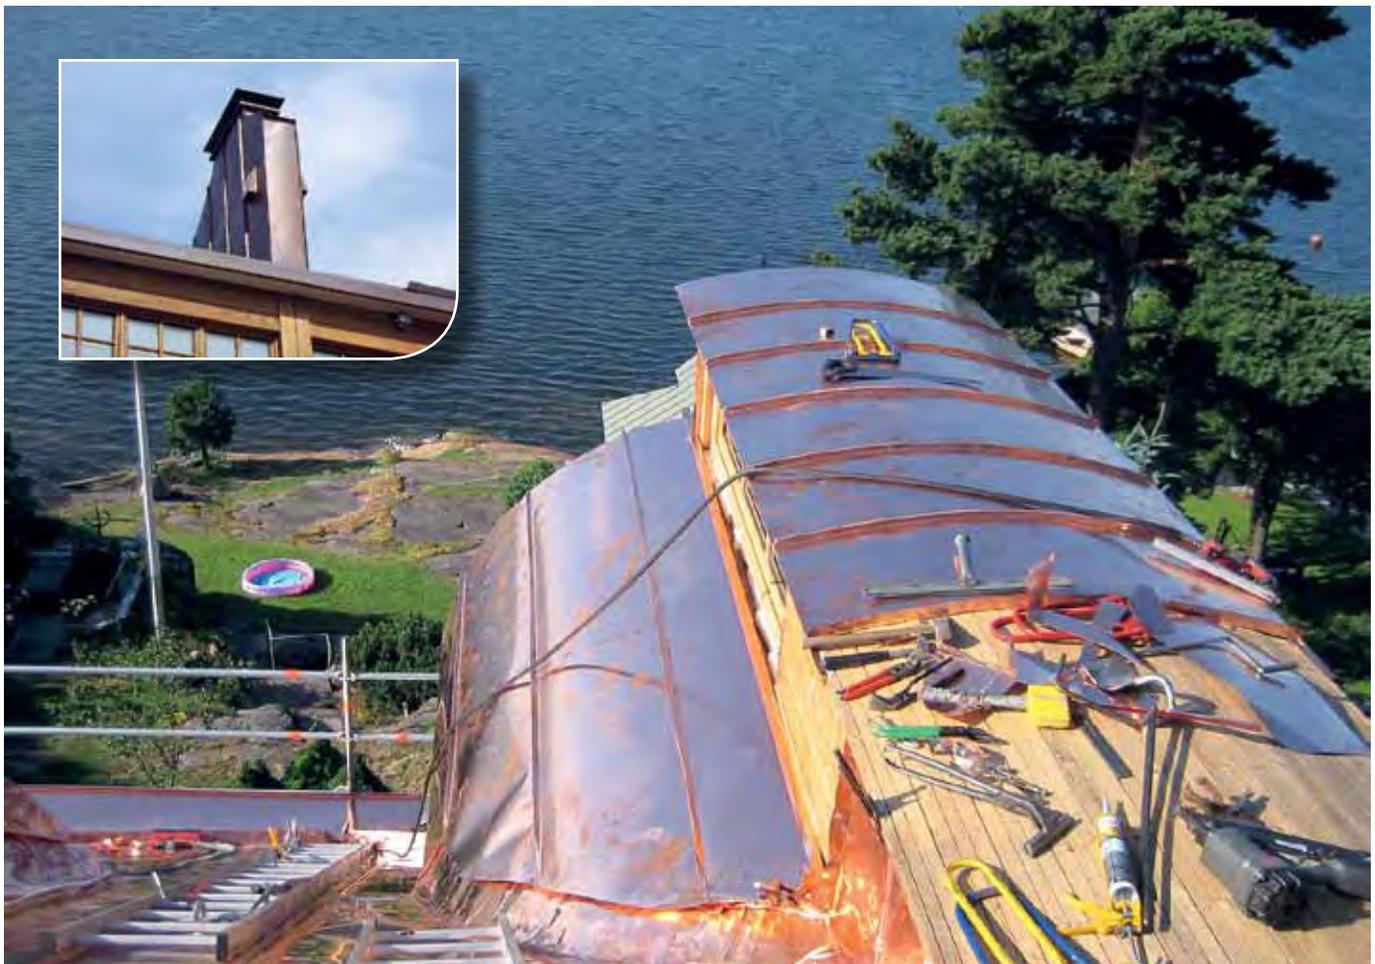
The roof was clad with 60-cm-wide copper strips, supplied in 200-kg coils ready to be cut and shaped into correctly sized pieces for use in different places. The 500m<sup>2</sup> roof has various details demanding a particularly high level of skill from the installation crew – a local sheet-metal company. Copper has also been used in the unusual rainwater system, the distinctive architect-designed chimney, and even protective cladding for the fence. The highly individual window frames are copper-clad, too. This house is full of small, delightful details – all beautifully executed and a real celebration of copper craftsmanship. It's now a year since the new copper was installed and it has oxidized into a soft brown colour. The owners are pleased with their choice and know that the roof will last for many generations.
